# Planning Conditions Compliance Statement

Oakfield House, 478 Station Road, Dorridge, Solihull, B93 8HE

Planning Conditions: 4, 5, 7 and 8

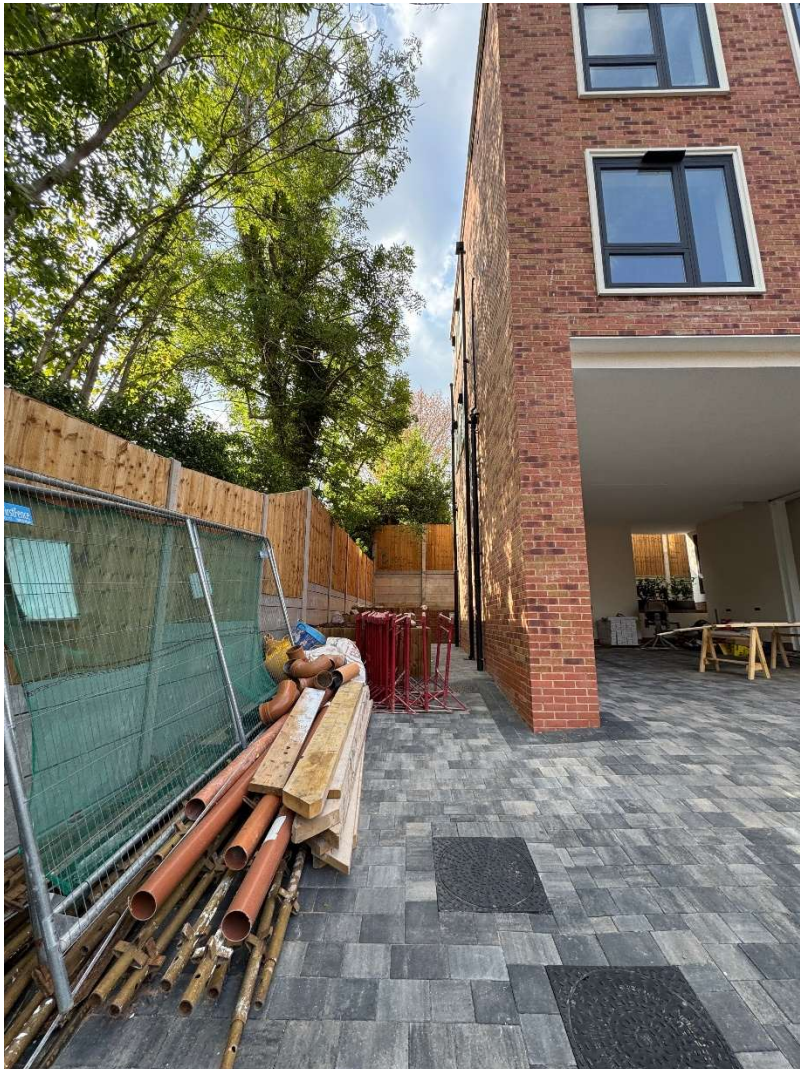
The site boundary adjacent to the railway continues to be secured by the **existing palisade metal fencing**, which remains intact and fully functional. In addition, a **new high-level timber feather-edge screen fence** has been installed on the residential boundary, comprising **three and a half levels of concrete fence panels** with timber screening above. Together, these two layers of fencing provide a robust, secure, and trespass-resistant barrier that exceeds the minimum requirements of the condition.

High level timber feather edge fencing on three and a half levels of concrete fence panels in front of existing palisade fencing on the railway border.
